TSI 01/10

Engine failure –
is the cylinder head gasket to blame?

Failure of the 2-layer metal gasket for motorcycles

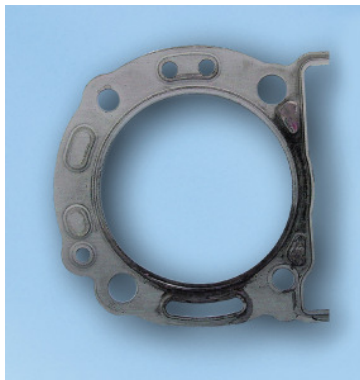
The metal stopper layer and the functional layer show significant black discoloration near the cooling duct. Gas has leaked between the stopper layer and the functional layer.

*Stopper layer,
engine block side*

The bolt tightening torque was too low, generating insufficient sealing compression.

- Engine components not flat (deformed by overheating).

During installation, ensure that the specified bolt tightening torque is applied.

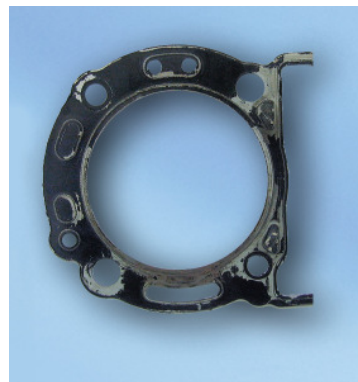
*Functional layer,
head side*
