TSI 04/10

Tips from the gasket expert

Engine failure – is the cylinder head gasket to blame?

Gas blow-by on the metal layer gasket

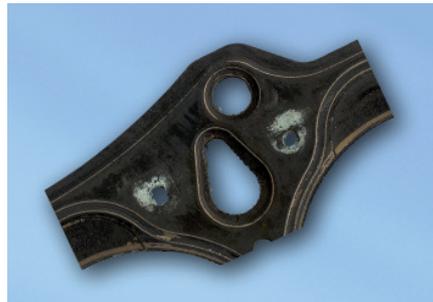
Clear linear impressions can be seen in the area of the water ducts. These come from the cylinder head sealing surfaces and run in the direction of the combustion chamber. The water passages have an obvious light coloration.

The surface structure of the cylinder head was machined either insufficiently or not at all, resulting in the blow-by of combustion gases into the cooling circuit and overheating (pressure build-up).

- The air was not removed entirely from the cooling system so the coolant did not circulate.
- Cooling circuit was interrupted (water pump, thermostat, fan).
- High exhaust back pressure caused engine to overheat (e.g. defective catalytic converter).

Check the condition of the sealing surfaces very closely before installation and ensure that the cylinder head is. If necessary resurfacing by a specialist.
