# Tips from the gasket expert

## Engine failure – is the cylinder head gasket to blame?

# Gas blow-by on the metal layer gasket

## Failure due to pressure build-up in the cooling system

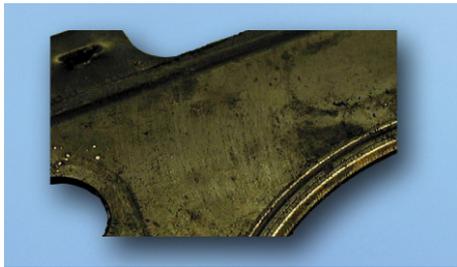
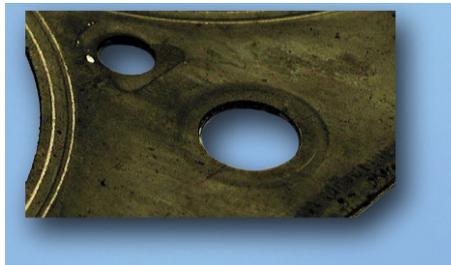
Clear linear impressions visible on the multi-layer metal-elastomer cylinder-head gasket. These impressions were made by the cylinder-head sealing surfaces and run in the direction of the combustion chamber.

The surface structure of the cylinder head was machined either too coarsely or not at all. This caused combustion gas blow-by into the cooling circuit and overheating (pressure build-up).

- The air was not removed entirely from the cooling system so the coolant did not circulate.
- Cooling circuit was interrupted (water pump, thermostat, fan).
- High exhaust back pressure caused engine to overheat (e.g. defective catalytic converter).

Check the condition of the sealing surfaces very closely before installation and ensure that the cylinder head is. If necessary resurfacing by a specialist.

Para-meters	Metal/soft-material	Multi-layer metal	Metal-elastomer
$R_z$	15 - 20 $\mu\text{m}$	11 $\mu\text{m}$	11 - 20 $\mu\text{m}$
$R_{\text{max}}$	20 - 25 $\mu\text{m}$	15 $\mu\text{m}$	15 - 20 $\mu\text{m}$
$W_t$		8-10 $\mu\text{m}$
